# ANNUAL REPORT FOR 2010

**Bald Creek Site #1 Mitigation Site  
Yancey County  
TIP No. R-2518B**

Prepared By:  
Natural Environment Unit & Roadside Environmental Unit  
North Carolina Department of Transportation  
December 2010

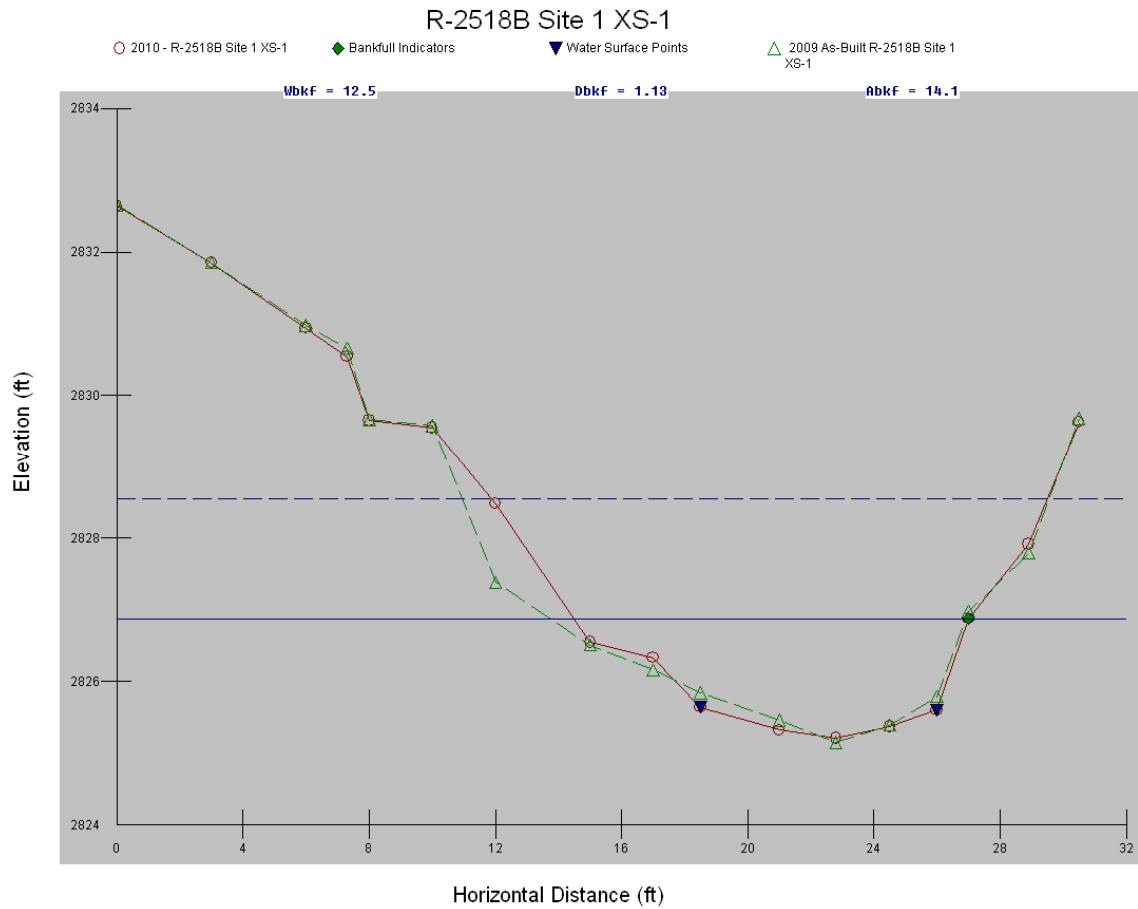
Based on comparisons of the As-Built to Year 1 monitoring data, all of the cross sections appear stable with little or no active bank erosion. Graphs of the cross sections are presented in Appendix A. Future survey data will vary depending on actual location of rod placement and alignment; however, this information should remain similar in appearance. The longitudinal profile showed that the channel was stable for the 2010 monitoring evaluation. Pebble counts were not required per the permit conditions and therefore were not completed.

Site #1: Cross-Section #1 (Riffle) Abbreviated Morphological Summary					
	2010	2011	2012	2013	2014
Bankfull Cross Sectional Area (ft <sup>2</sup> )	14.15				
Maximum Bankfull Depth (ft)	1.67				
Width of the Floodprone Area (ft)	17.62				
Bankfull Mean Depth (ft)	1.13				
Width/Depth Ratio	11.07				
Entrenchment Ratio	1.41				
Bankfull Width (ft)	12.51

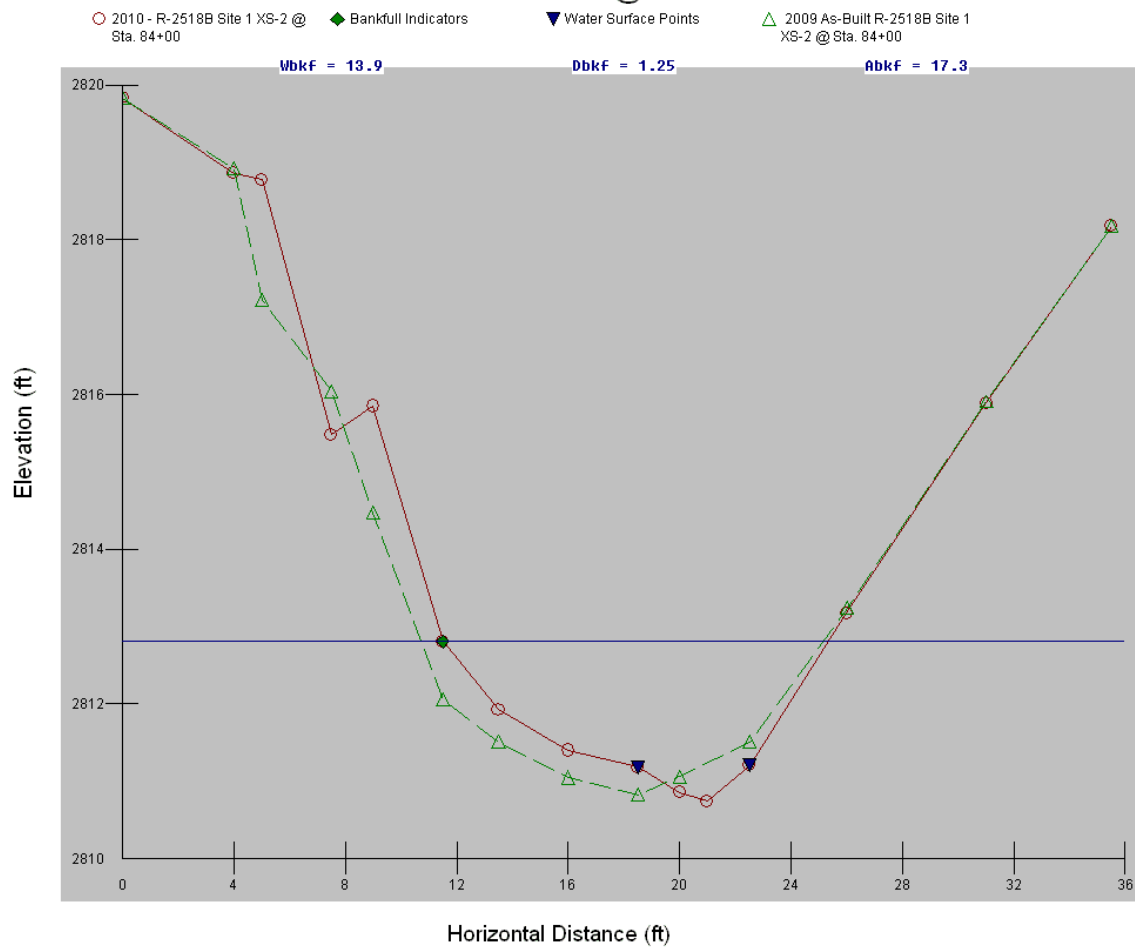
# R-2518B Site 1 XS-2 @ Sta. 84+00

## Site #1: Cross-Section #2 (Pool) Abbreviated Morphological Summary

2010	2011	2012	2013	2014
Bankfull Cross Sectional Area (ft <sup>2</sup> )	17.28				
Maximum Bankfull Depth (ft)	2.07				
Bankfull Mean Depth (ft)	1.25				
Bankfull Width (ft)	13.86

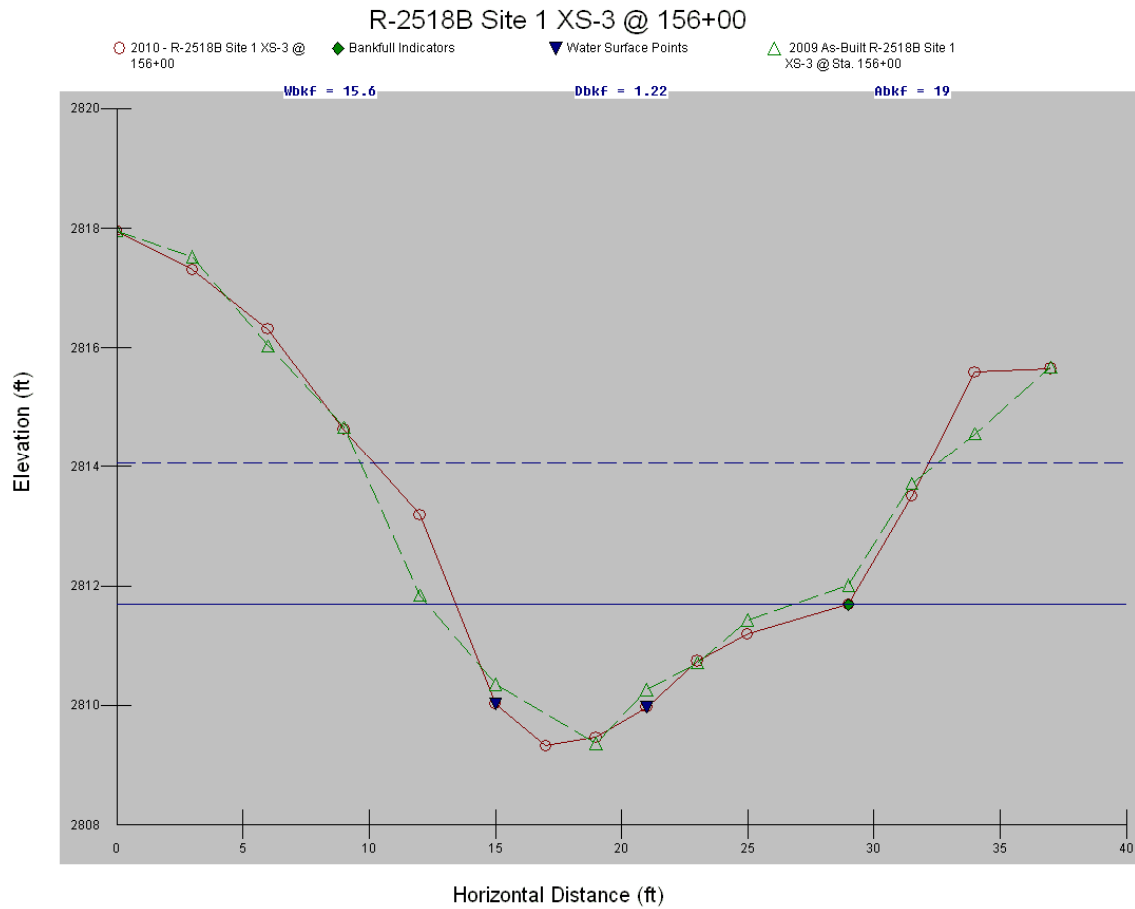
Site #1: Cross-Section #3 (Riffle) Abbreviated Morphological Summary					
	2010	2011	2012	2013	2014
Bankfull Cross Sectional Area (ft <sup>2</sup> )	19.03				
Maximum Bankfull Depth (ft)	2.37				
Width of the Floodprone Area (ft)	21.98				
Bankfull Mean Depth (ft)	1.22				
Width/Depth Ratio	12.77				
Entrenchment Ratio	1.41				
Bankfull Width (ft)	15.58

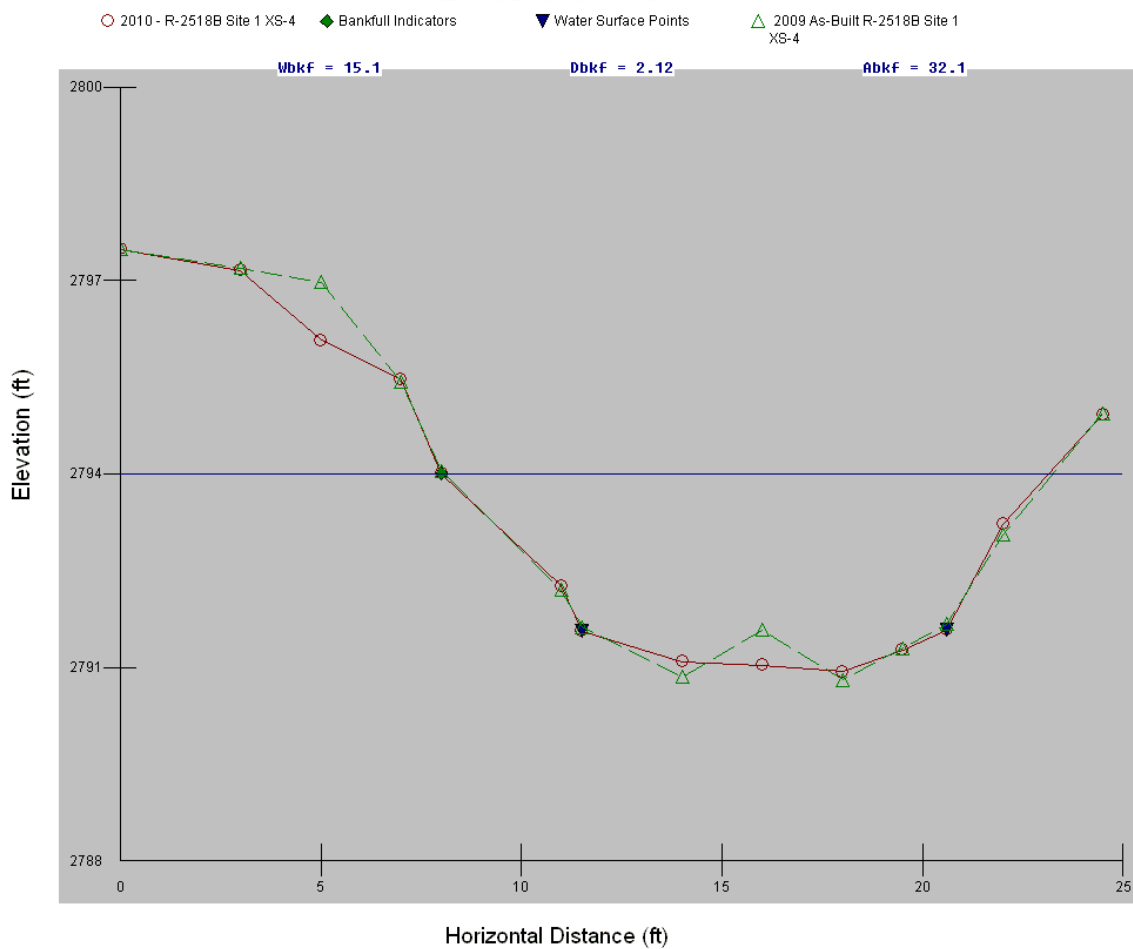
# R-2518B Site 1 XS-4

## Site #1: Cross-Section #4 (Pool) Abbreviated Morphological Summary

2010	2011	2012	2013	2014
Bankfull Cross Sectional Area (ft <sup>2</sup> )	32.13				
Maximum Bankfull Depth (ft)	3.07				
Bankfull Mean Depth (ft)	2.12				
Bankfull Width (ft)	15.15
